# An archaeological watching brief at Heddon-on-the-Wall and the probable location of Milecastle 12

Matthew S. Hobson

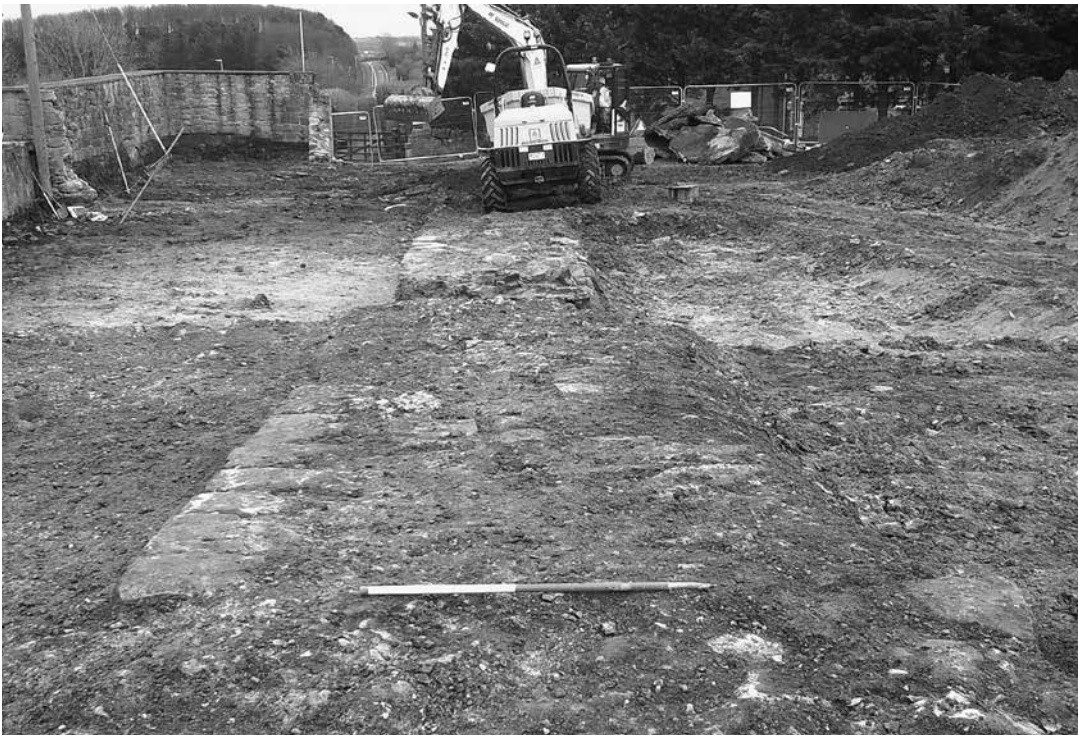
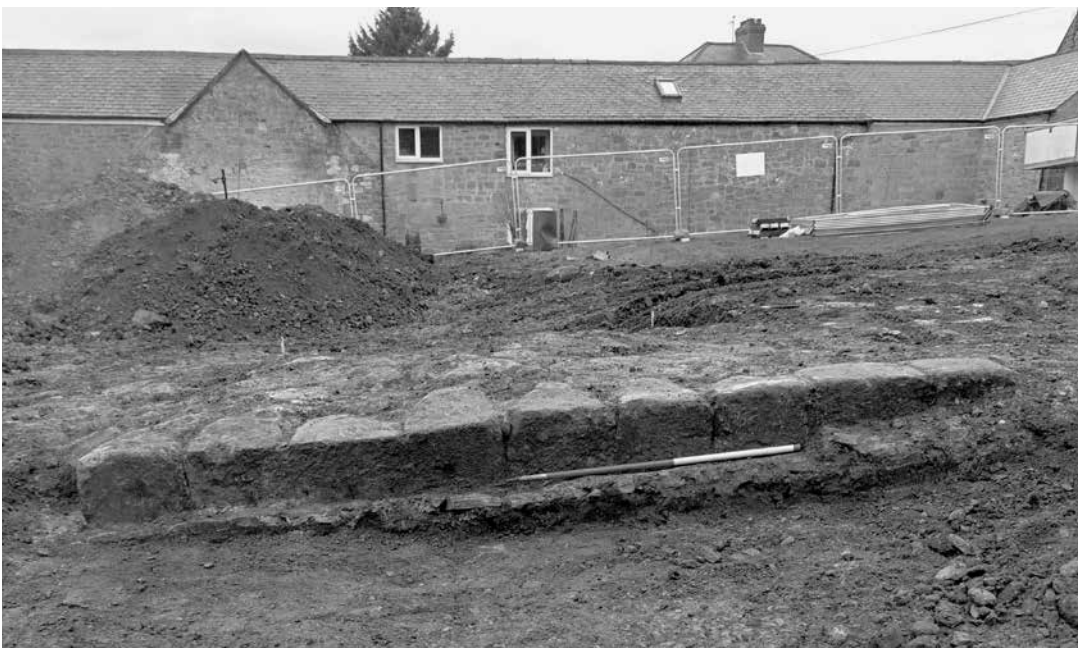
Fig. 4 and 5 Surviving sections of Hadrian's Wall (scale = 1 metre, shots face east and south respectively).

Work on the watching brief in March 2019 in the centre-north of the site revealed the remains of two sections of the very base of Hadrian's Wall. It appears that these sections of wall had been preserved thanks to the fact that they sat in a slight natural depression, which had protected them from truncation. A distance of 90.4 metres could be measured between the extant portion of Hadrian's Wall exposed by Anderson, just to the east of the development site where it can be seen to be cut by a medieval kiln, and the eastern end of the section discovered during the watching brief (fig. 2). The section to the west measured 13.35m long, the section to the east measured 4.85m, and the two sections were separated by a truncation event 2.40m wide (fig. 3, {109}). In both surviving sections several facing stones remained in position on the northern side of the wall. It appeared that the southern edge had been truncated during the construction of the former farm buildings along most of its length. A single surviving facing stone on the southern edge allowed the total width of the wall to be measured at 2.95m. This width is more or less consistent with other surviving sections of the Broad Wall foundations, some of which have been measured at as much as 3.5m (Breeze 2006, 53; Symonds and Mason 2009, 38, Table 2). The maximum surviving height of the wall, measured from the base of its foundations to the top of its facing stones, was 0.45m.

The core of the wall was formed of worked, irregular sandstone blocks, bonded together with clay (figs 3 and 4). The facing stones were also worked, providing a regular foundation course with no bonding material observed (fig. 6, {114}). The observed facing stones averaged 350mm by 500mm in plan. The long edge was most often positioned at a right angle to the line of the wall (maximum depth into the wall 550mm). In some cases, the stone tapered to a

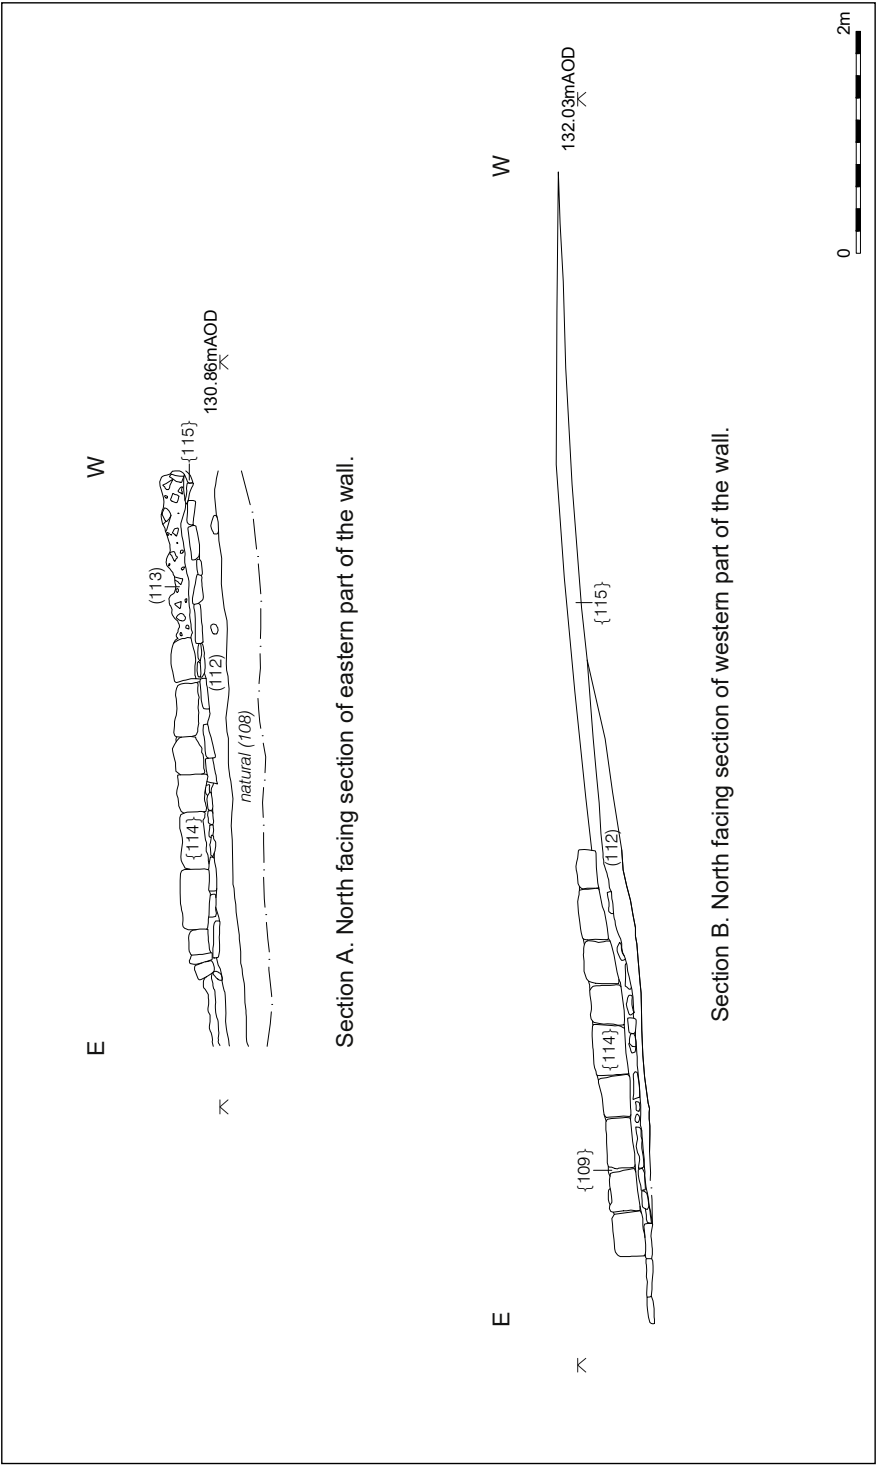
Fig. 6 North-facing sections/elevations of surviving sections of Hadrian's Wall and sealed deposits beneath.

narrower width along its back edge to aid bonding with the core, but others were more cuboid in shape. Occasionally a facing stone was oriented with its longest edge along the line of the wall, in each case presumably because the long edge possessed the flattest face. The height of the facing stones ranged from 200mm to 300mm, with the average being around 260mm (figs 4 and 5). The facing stones overlaid a series of sandstone slabs which formed a base for the wall (fig. 6, {115}). These slabs were bedded within a firm yellow clay. At the western extent these slabs did not survive. To the east, they had been laid directly upon a soft dark brown sandy clay layer, interpreted as a buried soil. The buried soil measured 0.2m in depth on average and contained small amounts of rounded pebbles and occasional charcoal flecks (fig. 6, 112). This buried soil was located directly above the sandstone bedrock (fig. 6, 108) and only survived directly below the preserved sections of the wall.

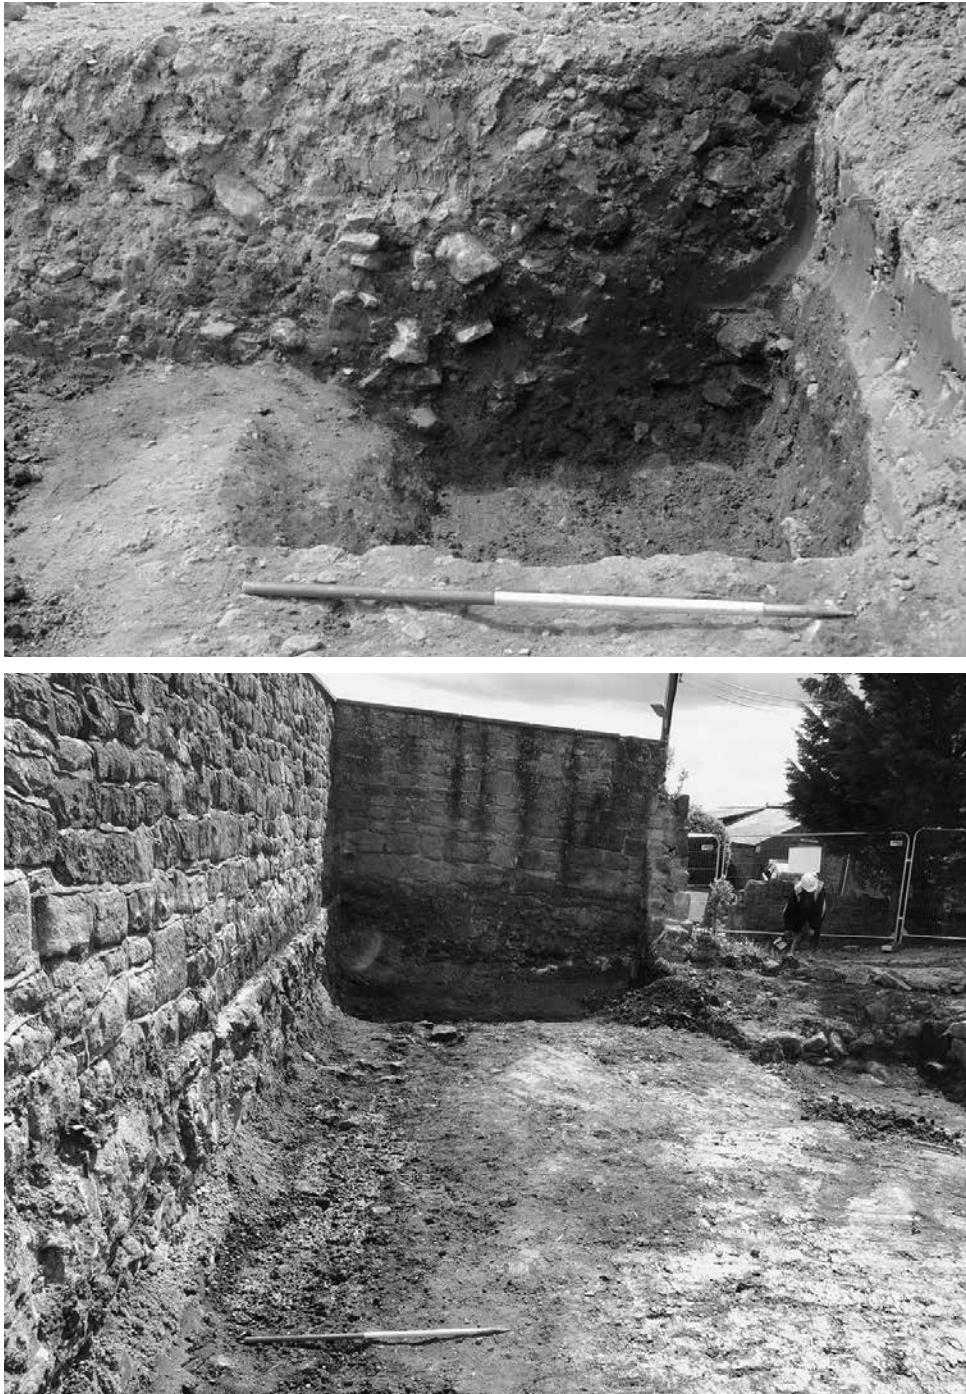
Fig. 7 and 8 Surviving sections of Hadrian's Wall (scale = 1 metre, shots face east and south respectively).

The southern edge of the Wall Ditch was also located during the watching brief in March 2019 where it was expected, in the north-east corner of development area (figs 7 and 8). The feature was confirmed not to be the construction cut of the former diesel store, as it continued under both the eastern and western surviving walls of that structure and did not deviate at the positions of its return walls. In addition, the upper fill of the Wall Ditch had been cut by a near-vertical sided feature, which was interpreted as foundation cut for the northern wall of

The southern edge of the Wall Ditch (fig. 8) was located about 8 metres to the north of the line of Hadrian's Wall (fig. 2). This is slightly more than the standard 6.1m width of the northern berm between the Wall and defensive ditch (Symonds & Mason 2009, 45), although the greater truncation observed within the eastern part of the site could explain the increased distance between the two features. The northern edge of the Wall Ditch was not observed during the investigation. The upper fills of the Wall Ditch that were encountered during these interventions all appeared to have accumulated during the Post-medieval period.

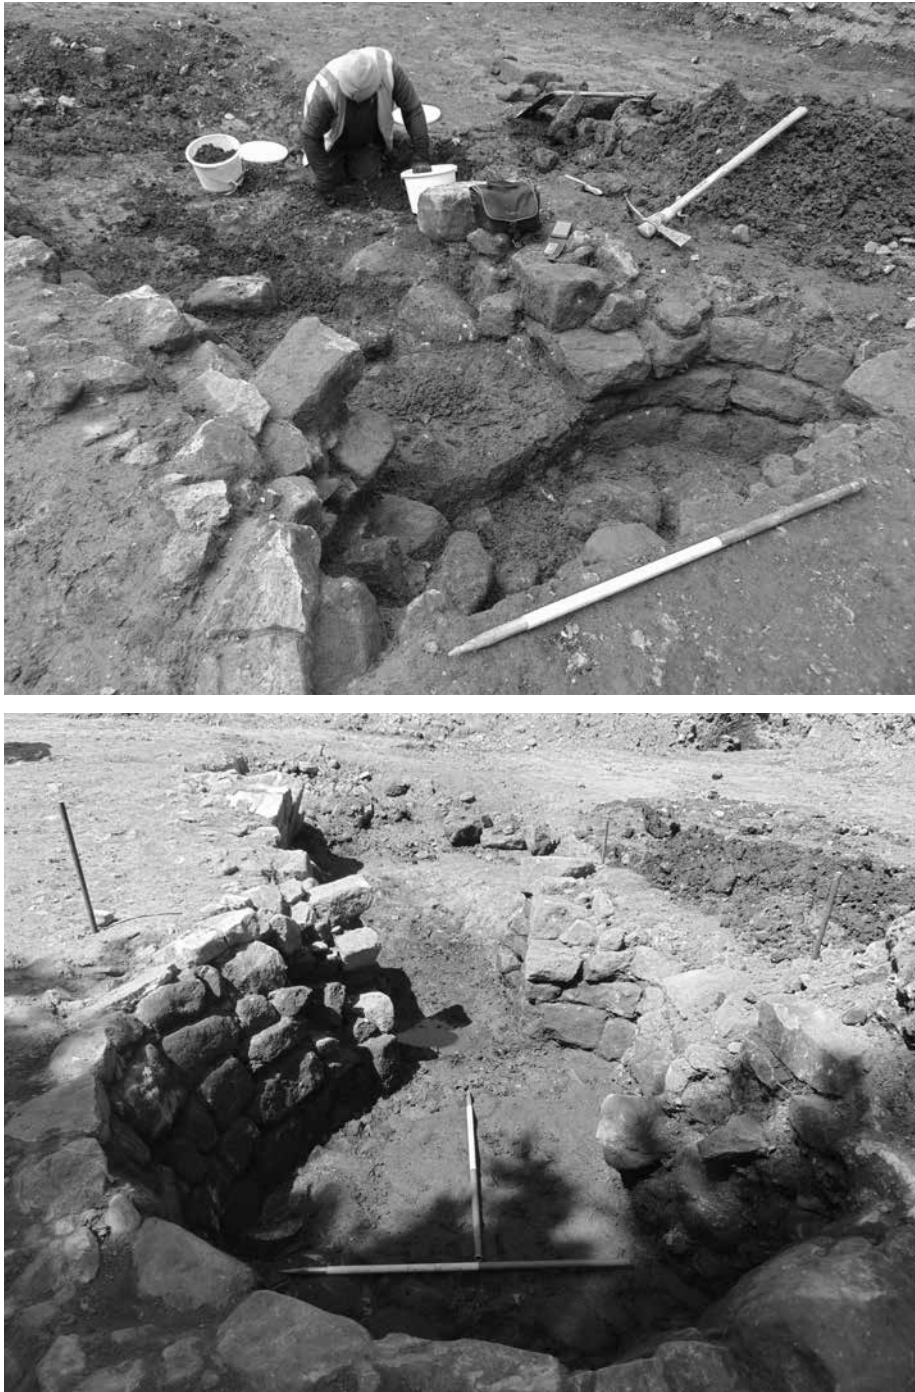
Fig. 10 and 11 Top: Medieval kiln mid-excavation (scale = 1 metre, Shot faces north-west).  
Bottom: Medieval kiln post-excavation (scale = 1 metre, shot faces west).

Following the removal of most of the structural elements of the old diesel store in the north-east corner of the development area, the remains of a stone-lined medieval kiln were revealed (figs 10 and 11). Unlike the previously known medieval kiln, which was cut into the actual fabric of the broad wall 66m to the east, this feature was located about 3.5m north of the Wall and 1.5m south of the Wall Ditch (fig. 2). The kiln comprised a bowl-shaped cut which had been packed around the periphery with squared sandstone blocks forming a circular kiln wall (fig. 9, {121}). The kiln had a maximum internal diameter of 2m and survived to a height of 0.95m. The base of the kiln comprised a deposit of loosely packed irregular sandstone blocks {129} bedded in a dark grey silt {130}. It is unclear whether this represented a crude surface of the feature or a foundation deposit for a floor.
